HOME INSPECTION REPORT

# Sample Inspection — 1254 Maple Street, Wilmington DE

1254 Maple Street, Wilmington, DE 19801

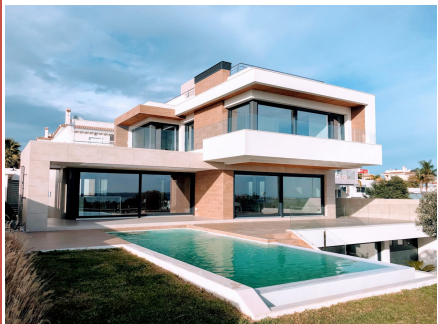
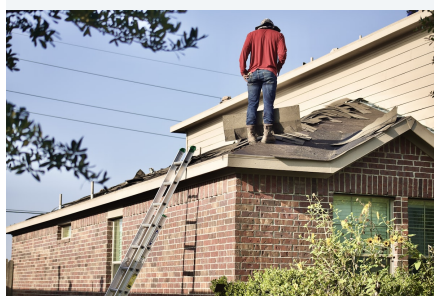
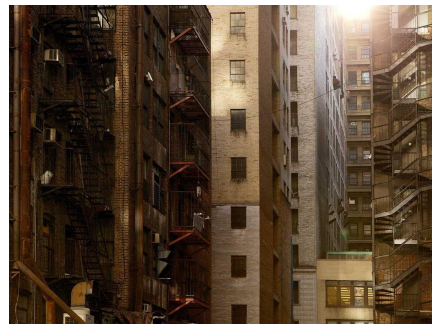
**MAJOR** /roof**Shingle granule loss along south-facing slope**

Shingle granule loss along... (1/3) — Roof,

Shingle granule loss along... (2/3) — Roof,

Shingle granule loss along... (3/3) — Roof,

Approximately 30% of the south-facing slope shows significant granule loss, exposing the underlying asphalt mat. The affected area spans roughly 200 square feet. Remaining service life is estimated at 3 to 5 years under normal weather.

**Recommendation: Obtain two quotes from licensed roofers for partial or full replacement. Defer cost planning no later than 2028.**

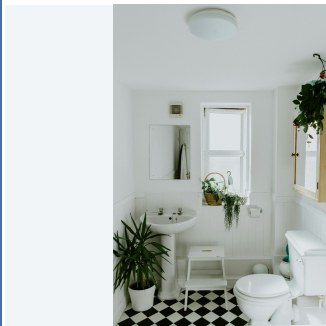
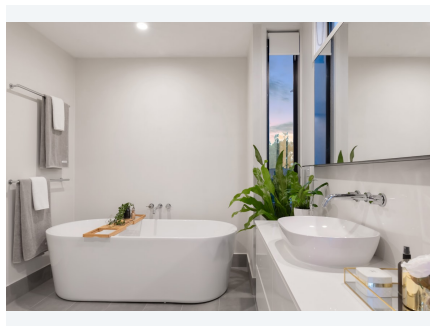
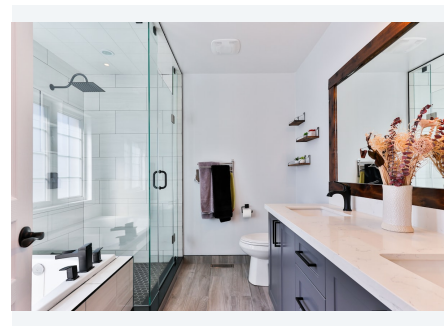
## Caulk failure at master bathroom tub surround

Caulk failure at master bathroom... (1/3) —

Caulk failure at master bathroom... (2/3) —

Caulk failure at master bathroom... (3/3) —

Silicone caulk at the tub-to-tile joint has pulled away in three locations. Risk of water migration behind the tile is low at present but will worsen if unaddressed.

**Recommendation: Remove old caulk and reapply with mildew-resistant silicone. DIY fix, under 1 hour.**
